THE OTTOMAN FORTRESS FROM HÂRȘOVA IN RECENTLY DISCOVERED RUSSIAN CARTOGRAPHIC SOURCES (18TH CENTURY)

Aurel-Daniel Stănică*, Constantin Nicolae**,
Mihai Anatolii Ciobanu***

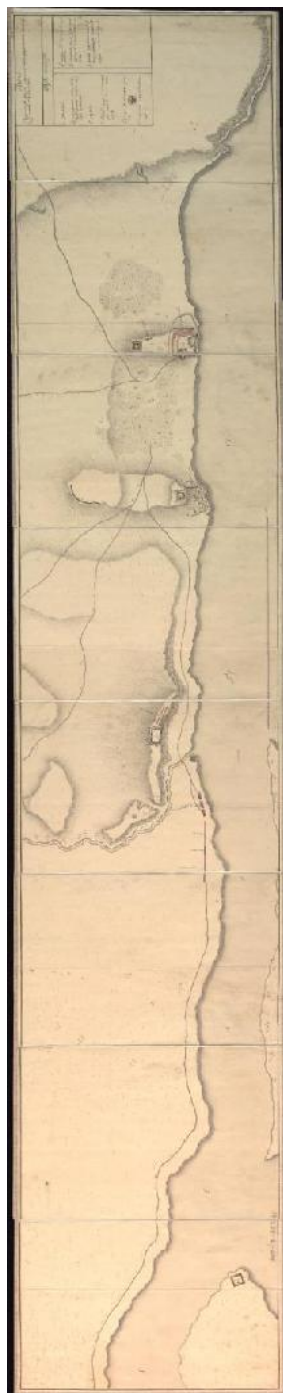
with information specific to the year indicated, including the defensive complex of Hârșova fortress, the urban structure, the repairs made by the Russians, the position of redoubts and Russian troops. The fortifications from Gâsca Island and Privalul Băroi to Citatel Hill (Dealul Cetății) are also shown on this plan.

Fig. 5. The Plan of Hârșova Castle with the indication of Vorstadt.

On plans 5 and 9, where a broader perspective on the fortress and the immediately adjacent area is used, the roads to the important localities nearby (Doeni-Dăeni) or further away (Siliștră, Babadag) are shown. It is interesting that the exit from the fortress is through the west, where the walls were broken by the explosion of a projectile, which we mentioned above, where a redoubt defended frontward by gabions is built. This detail suggests that the fortress was practically destroyed and was reduced, in the new circumstances, only to the western perimeter arranged by the Russian occupiers.

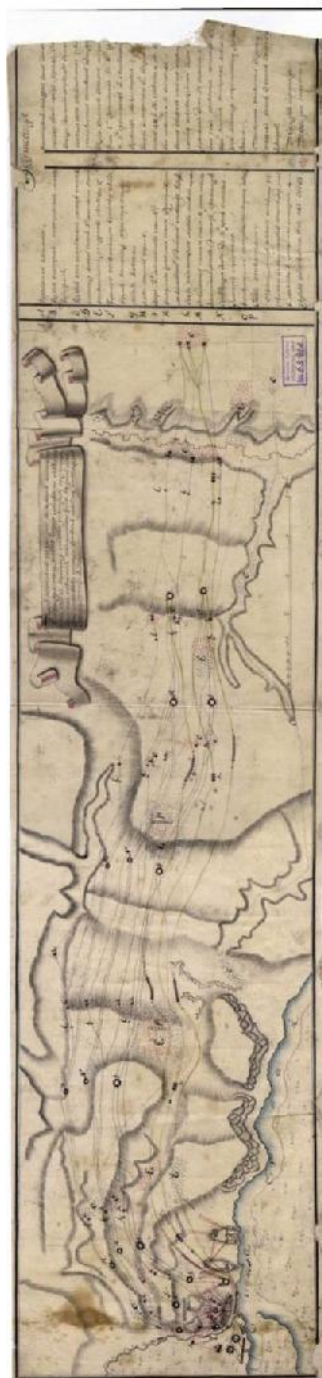
Fig. 6. The Plan of the Turkish Assault Attempt on Hârșova and the attack of the detachment of the 1st Moskovski Infantry Regiment on other fortifications.

N. The square which consisted of four companies which are shown with the letter "...". ("Строющиеся карей изъ «4» ротъ которые значатъ под литерою «...»");

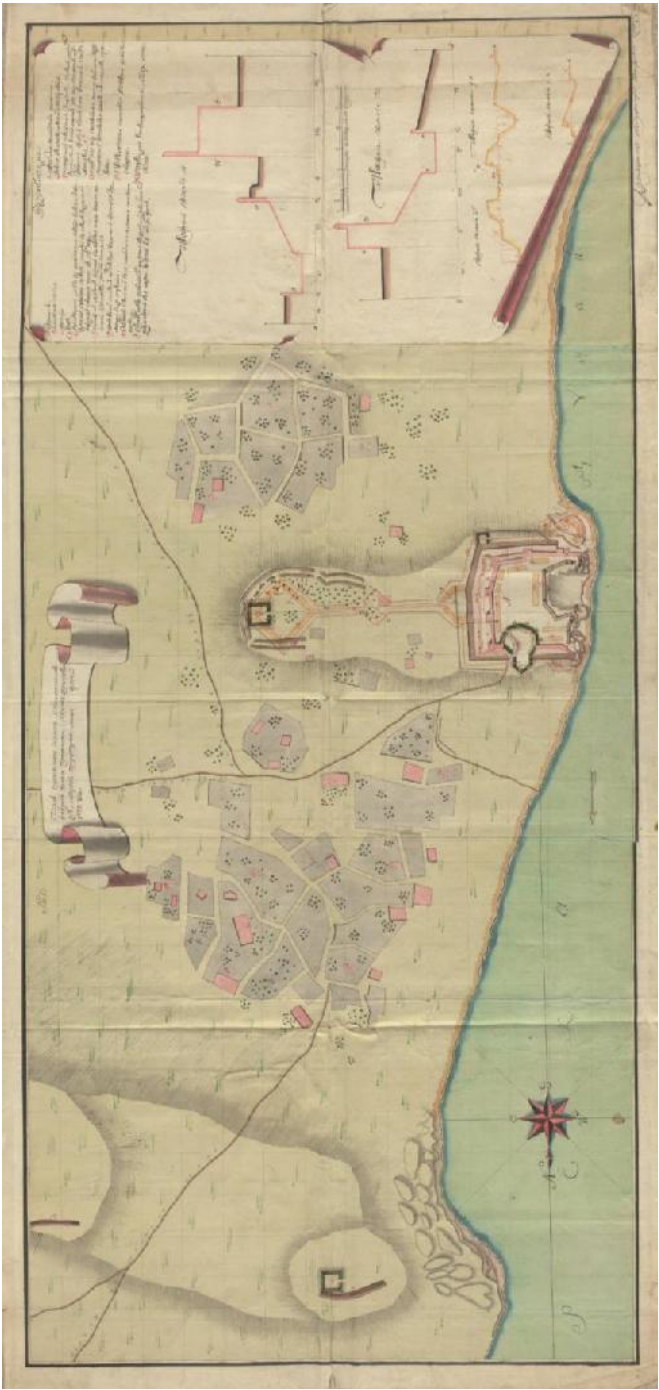
P. The suburbs that were burned during the siege ("Предмѣстїи которыи во время осады сожжены");

Fig. 9. The Plan of Hârşova Castle showing the project around it, and the new constructions follow in the report.

Q. The Turkish entrenchments, but now they are levelled ("Турецкии ретранжаменты, н^ые жъ оныи скрыты").

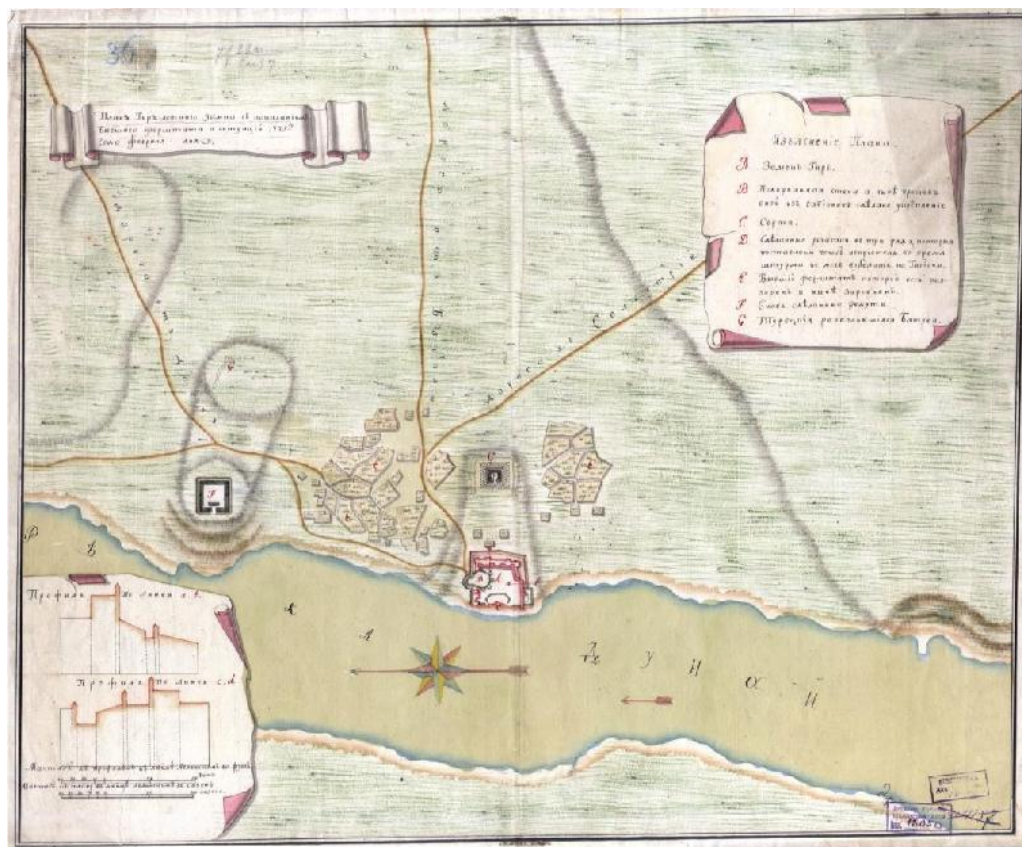
10. The tenth document is the *Plan of Hârşova Castle with the showing of the former suburb and the situation of the year 1775, February*, 48 × 58 cm (*План Гирзовскаго (!) замка с показанием бывшаго форштата и ситуаций 1775-го года февраля... дня*)⁶², which is in Kiev. Otherwise, we consider that in Romanov times both plans found by us in Kiev were in Odessa, being part of the Collection of maps and plans of the Museum of the Imperial Society of History and Antiquities established in 1839.

Fig. 10. The Plan of Hârşova Castle with the showing of the former suburb and the situation of the year 1775, February.

The town plan suggests an attention to detail and accuracy, which involved the input of military engineers, who resorted to field measurements.
